LOW-TEMPERATURE TESTING OF AN AH-1G
HELICOPTER EQUIPPED WITH ELASTOMERIC
FLAPPING AND FEATHERING BEARINGS IN
THE MAIN ROTOR

B. P. White

Bell Helicopter Company

July 1974

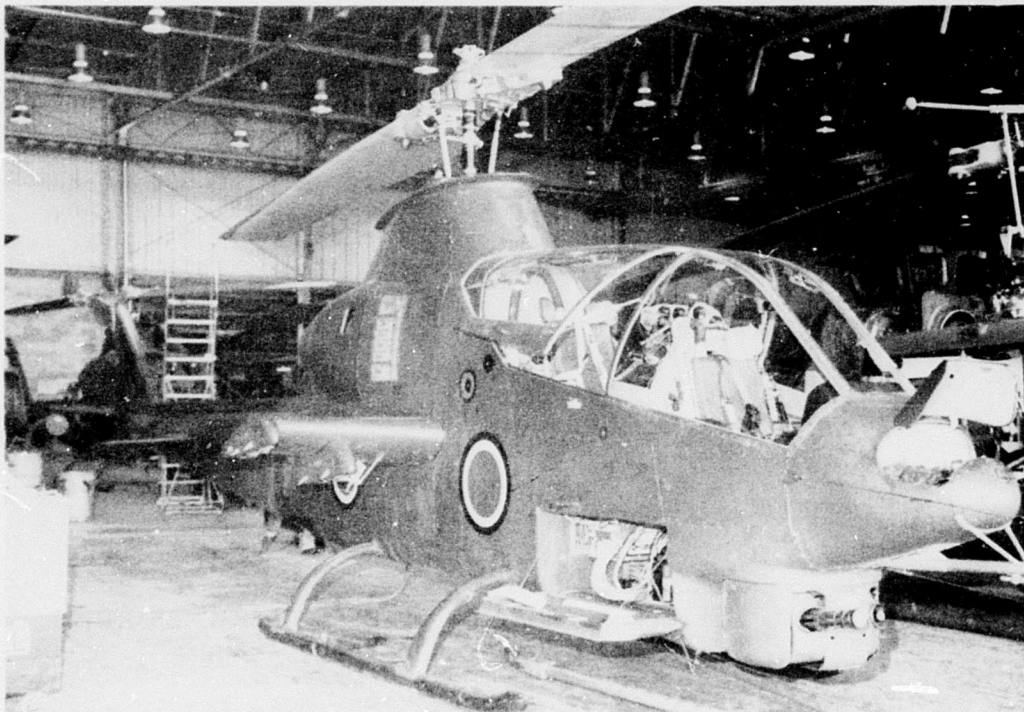
Figure 1. AH-1G Test Vehicle.

The AH-1G test vehicle, incorporating the BHC Model 540 all-elastomeric main rotor, is shown in Figure 1.

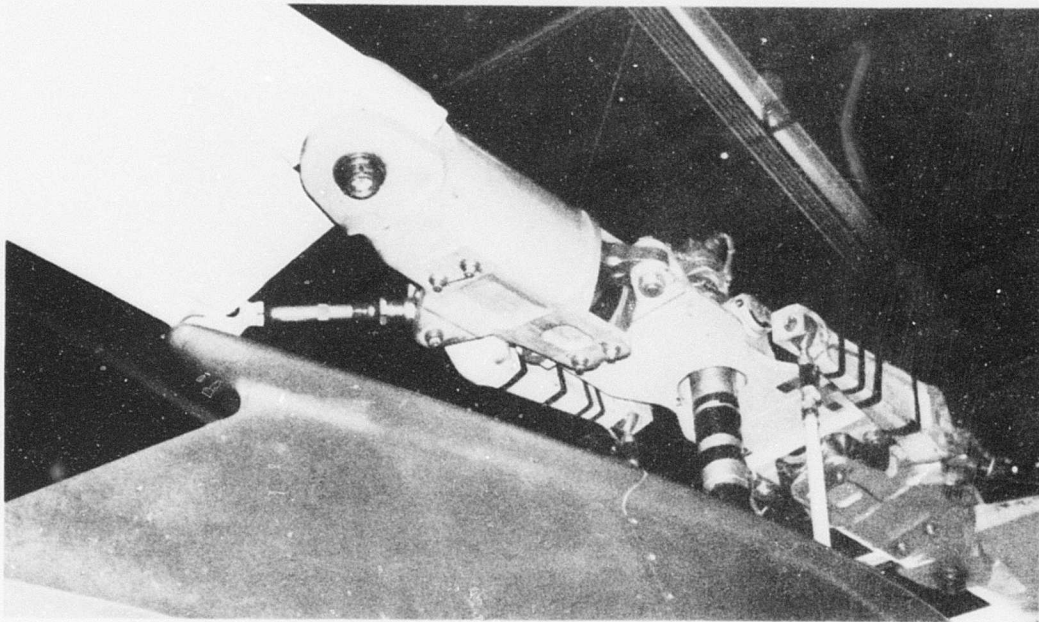
Figure 2. Model 540 Elastomeric Grip and Extension Assembly.

A Model 540 elastomeric grip and extension assembly is shown in Figure 2. The location of the elastomeric bearings may be determined by noting the position of the bearing retention bolts which project through the upper and lower sides of the grip.

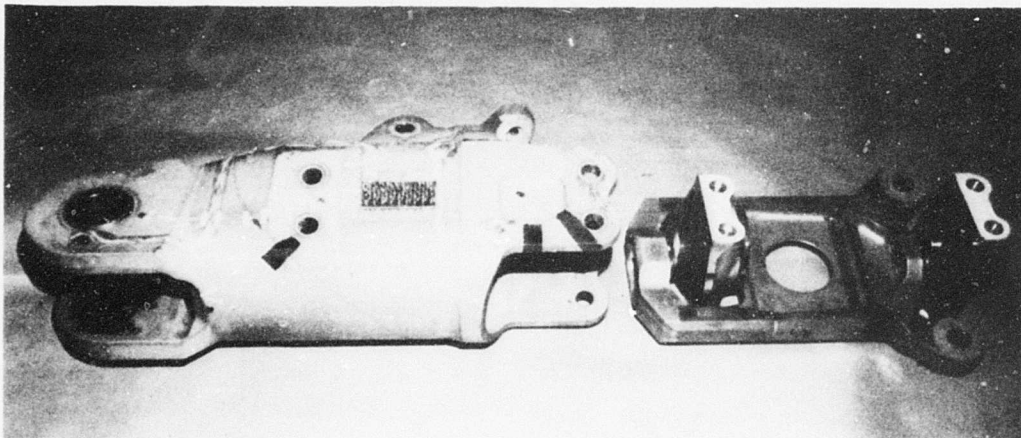
Figure 3. Disassembled Model 540 Elastomeric Grip, Extension, and Bearings.

Figure 3 shows the 540 grip, extension, and feathering bearings in a disassembled condition. The bearings have been placed in their approximate location with respect to the extension plate.

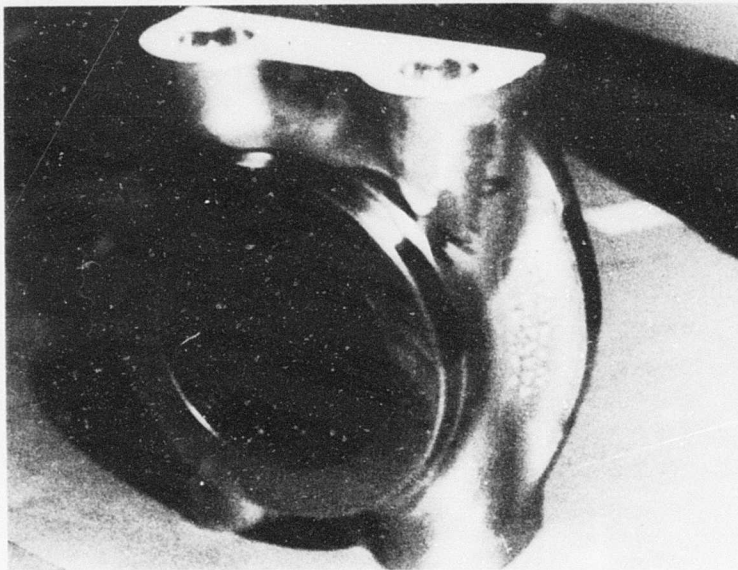
Figure 4. LM 726-4 Elastomeric Bearing.

The LM 726-4 bearing is shown in Figure 4. A sectioned bearing is shown in Figure 5 to explain the general construction of the elastomeric layers.

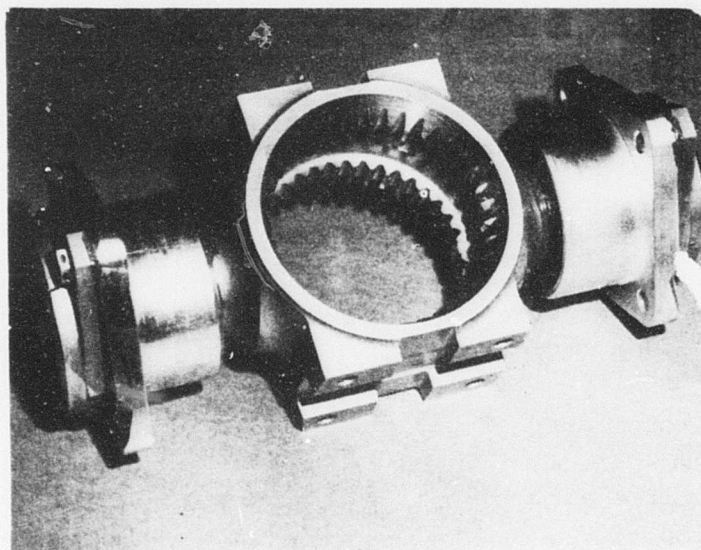
Figure 6. Elastomeric Flapping Bearing.

The elastomeric flapping bearing is shown in Figure 6. This bearing is presently being retrofitted to U. S. Army AH-1G helicopters.

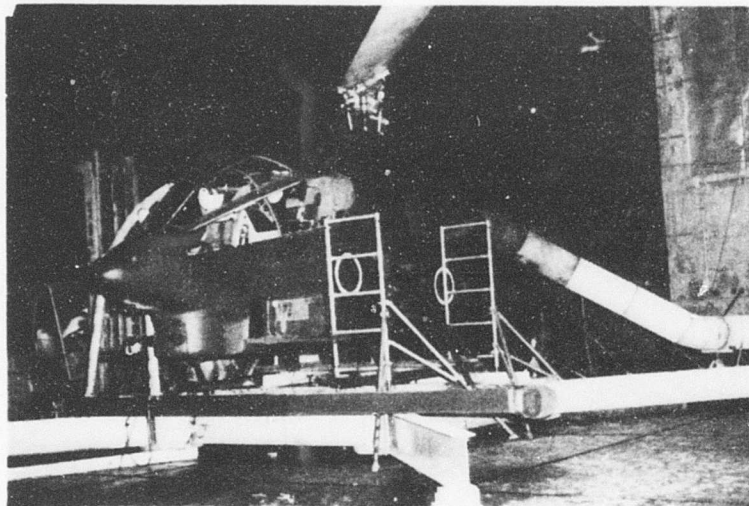
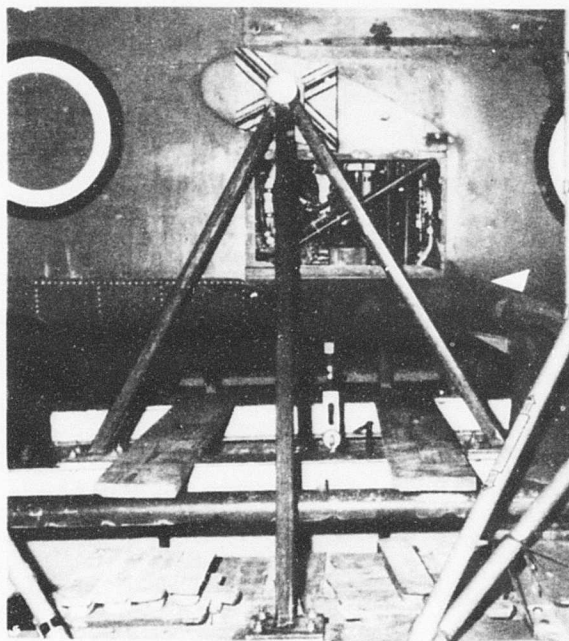
Figure 7. AH-1G Test Tie-Down.

- The elevator was replaced by a dummy elevator spar with tie-down fittings on either end. Each side of this spar was attached to a 5000-pound concrete block by a 5/8-inch cable.

- The tail skid was attached to two 5000-pound concrete blocks by means of a specially manufactured adapter on the skid. The purpose of this tie-down was to restrain lateral motion of the tail boom in the event of failure of some other tie-down component.

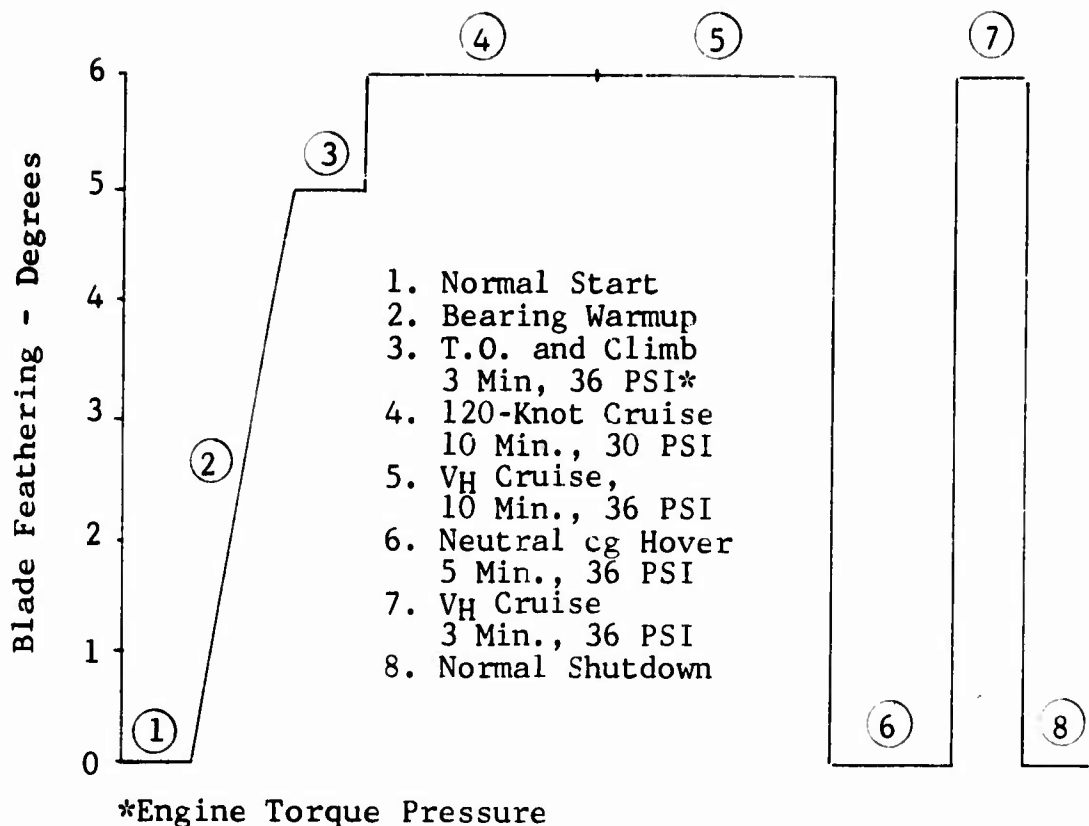
Figure 9. Test Mission Profile.

The elastomeric hub was usually cold soaked with the cyclic stick offset to 62.5 percent lateral and longitudinal cyclic to provide an adverse soaking condition which might produce control loads when rotating. At each test temperature, the helicopter was started and operated through a test profile which simulated the engine power and blade angles experienced by an AH-1G rotor when the vehicle was flown through the following mission:

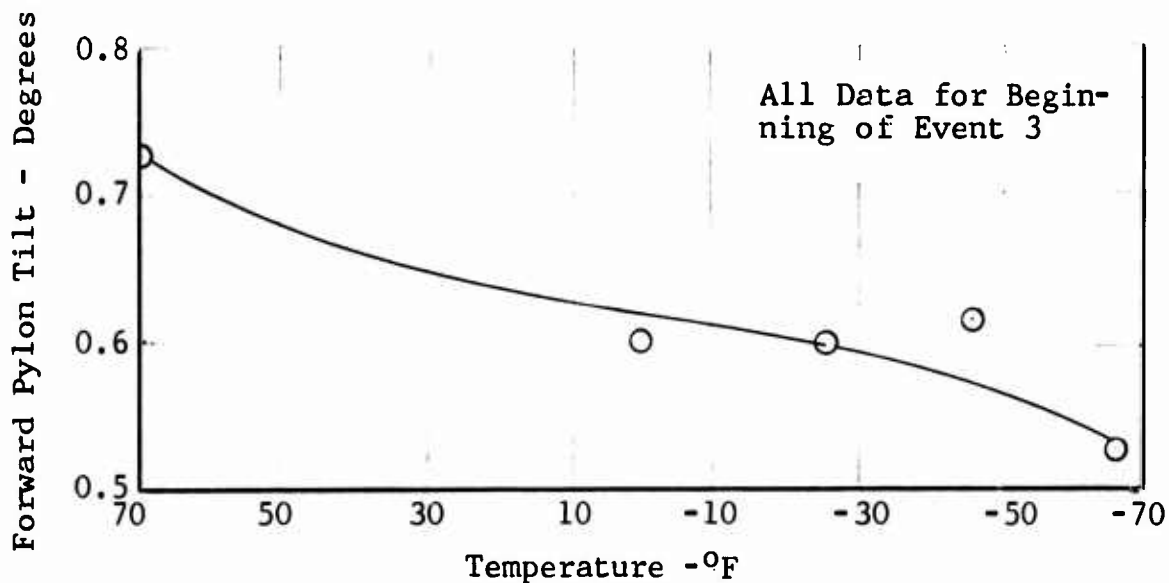
Figure 10. Pylon Tilt Versus Test Temperature.

This problem of excessive pylon tilt is a phenomenon associated with the tied-down condition in which the helicopter was operating in the hangar, and has no relevance to actual flight of the AH-1G. In forward flight, the relative wind causes the rotor to flap aft, and the fuselage is tilted forward. Both of these actions decrease pylon tilt with respect to the mast.

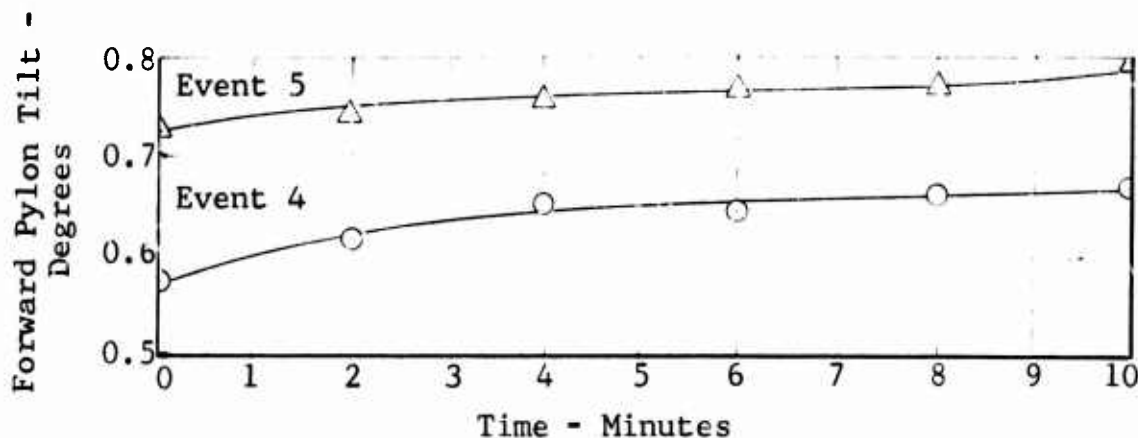
Figure 11. Pylon Tilt Versus Time During Test at -65°F .

As each mission progressed, the transmission mounts warmed, pylon spring rate decreased, and fuselage vibration diminished for a given operating condition. Figure 11 shows the variation of pylon tilt during a run at -65°F , for events 4 (6 degrees cyclic, 30 psi torque) and 5 (6 degrees cyclic, 34 psi torque).

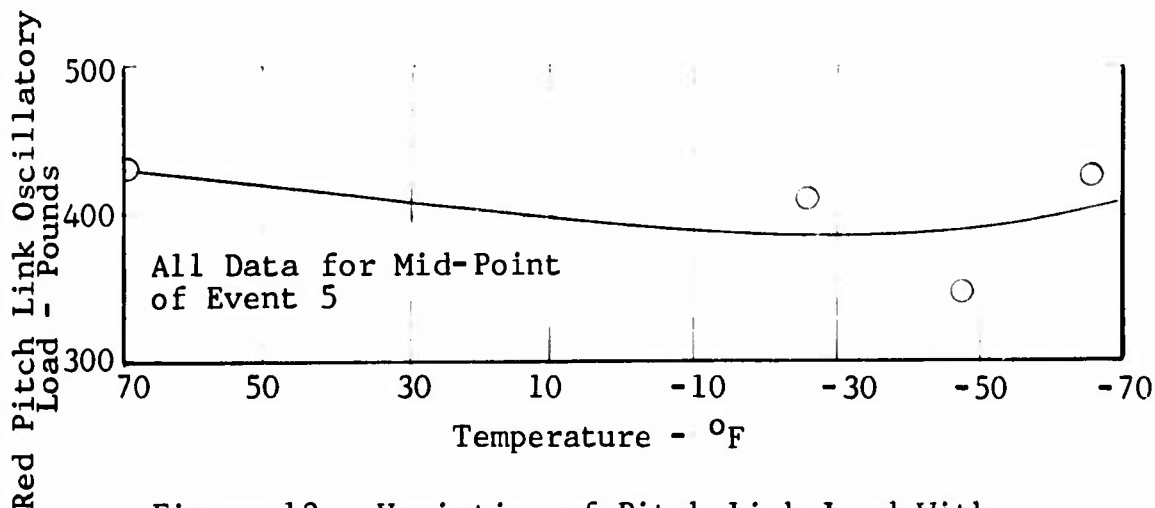
Figure 12. Variation of Pitch Link Load With Temperature for Standard 540 Hub.

Other than this minor problem with excessive pylon tilt, the test of the standard 540 rotor was uneventful. There was not a significant variation of control or blade loads between $+70^{\circ}\text{F}$ and -65°F . The behavior of the oscillatory pitch link loads midway through event 5 (V_H cruise) with temperature decrease is typical of control system load behavior, and is shown in Figure 12. The difference in loads can probably be attributed principally to data scatter.

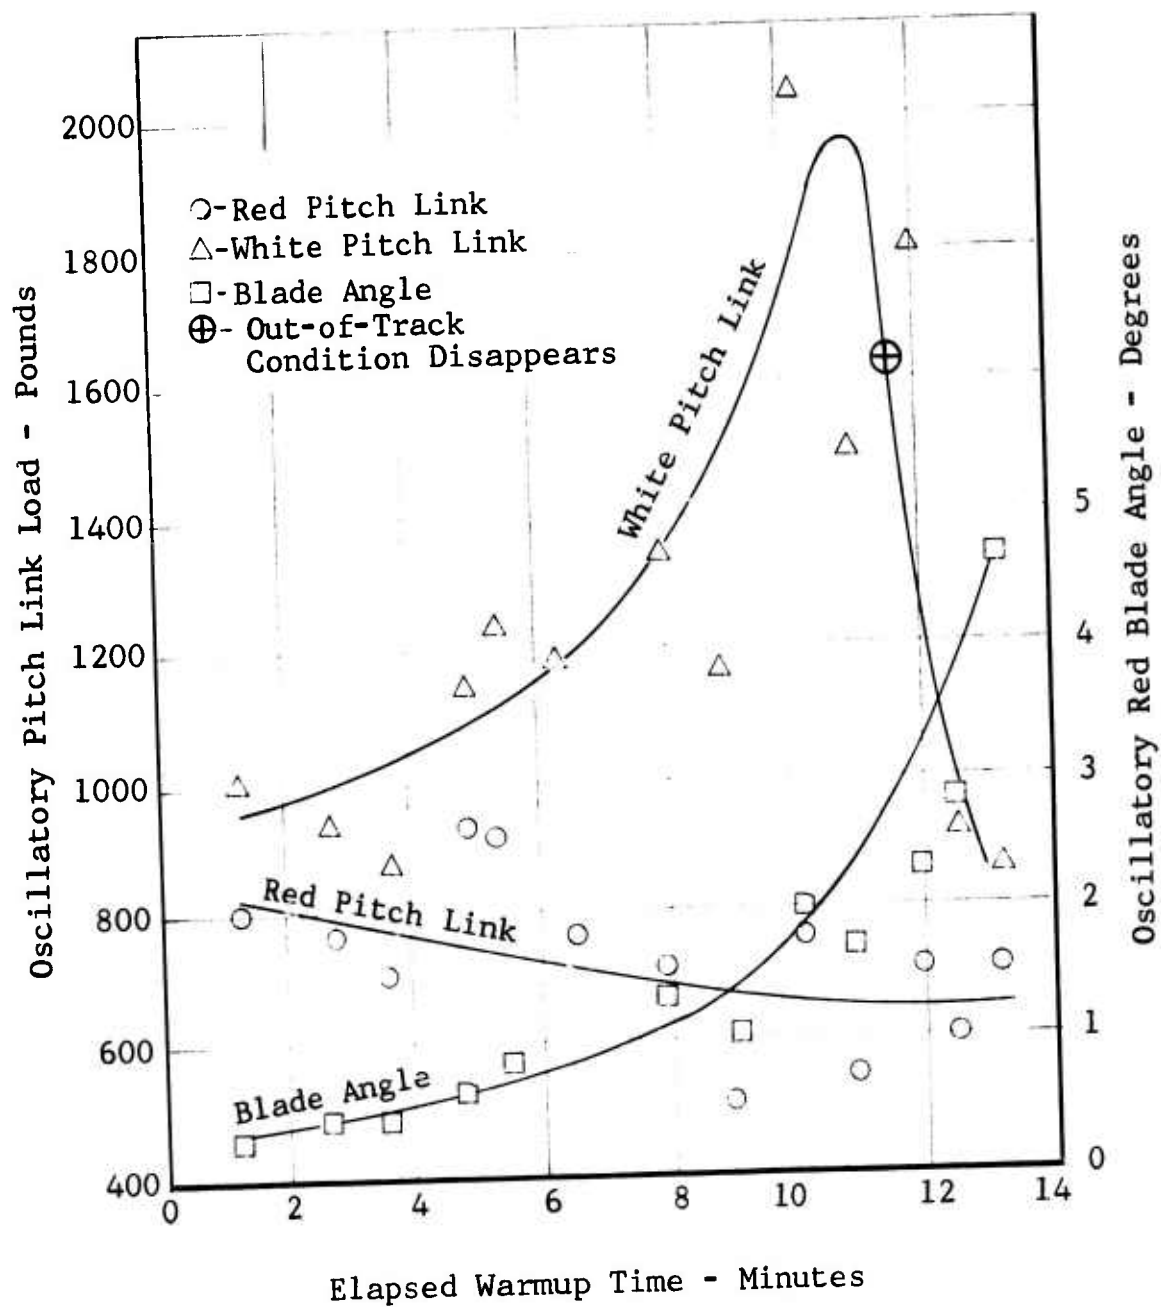
Figure 13. Rotor Behavior During Warmup at -65°F (GR 57).

Examination of the data from GR 57 again disclosed the presence of large differences in oscillatory cyclic pitch link loads. Figure 13 illustrates the behavior of pitch link loads during bearing warmup (event 2) of GR 57. At one point the white pitch link oscillatory load is almost three times that of the red pitch link. After white pitch load declines, large cyclic inputs are possible.

As may be seen in Figures 13 and 19, red pitch link oscillatory declined before white pitch link loads. This phenomenon was caused by differential warming of the bearings during preflight heating of the transmission input shaft coupling seals. Figure 20 shows an increase in red grip spring rates until shortly after the warmup event began. This phenomenon was probably caused by a cooling of the elastomeric bearings while rotating in the cold air after being heated prior to engine start. Figure 13 illustrates the same phenomenon for the white pitch link. Figure 13 also shows red grip spring rate to be declining when the warmup event began. This was probably caused by the elevation of the red grip temperature above the white during preflight heating of the transmission input shaft coupling seals, and the small amount of cyclic exercise imposed on the bearing during the crew chief's inspection.

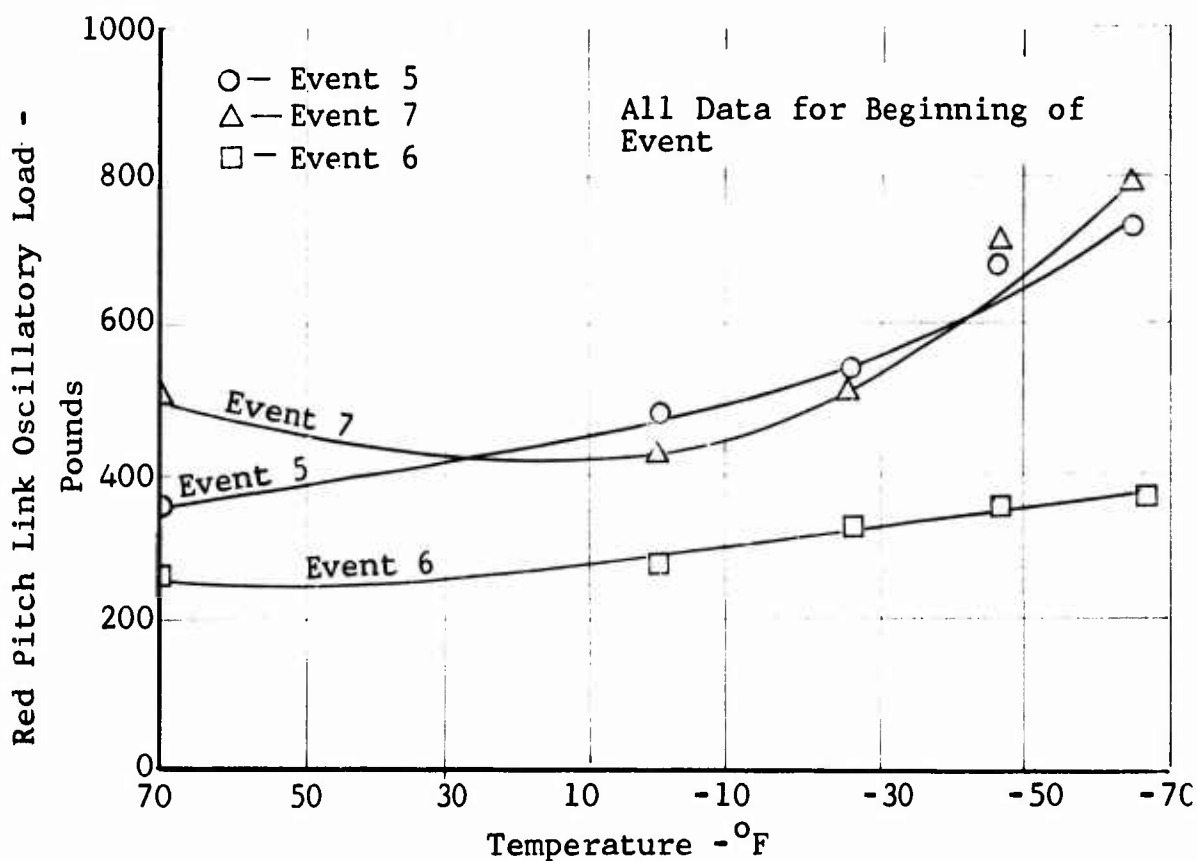
Figure 14. Red Pitch Link Load Versus Temperature.

Figure 14 depicts the variation of red pitch link oscillatory load with temperature for events 5 and 7 (120-knot cruise and V_H cruise) and event 6 (hover with zero cyclic blade pitch).

As should be expected, oscillatory loads are lower for zero cyclic pitch, and the oscillatory load for zero cyclic pitch does not increase so rapidly with temperature decrease. Events 5 and 7 both required the maximum cyclic pitch of 6 degrees, and a rise of oscillatory pitch link load with temperature decrease is apparent. However, all loads are significantly below the endurance level of 1460 pounds.

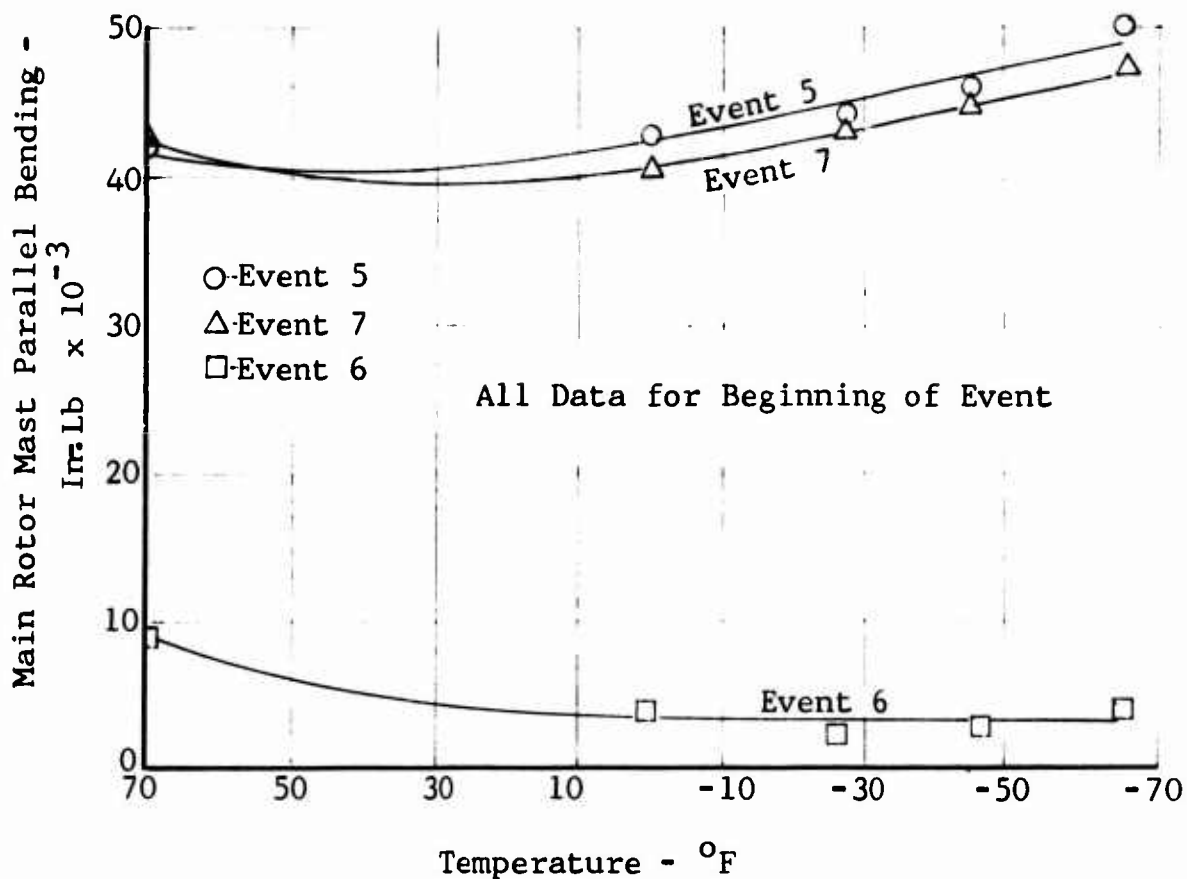
Figure 15. Main Rotor Mast Parallel Bending Versus Temperature.

Figure 15 shows the variation of main rotor mast parallel bending with temperature, plotted again for events 5, 6, and 7. This plot provides essentially the same evidence as the preceding figure, although the increase in loads for events 5 and 7 with lowering temperatures is not so significant.

The largest mast stress resulting from combined loading was obtained during the first elastomeric bearing test at -65°F, and was 32,000 psi. The endurance level for the mast is 36,700 psi. The largest stress obtained with the

standard hub was 29,500 psi, so while the elastomeric hub does provide increased mast stress, that stress is still relatively low.

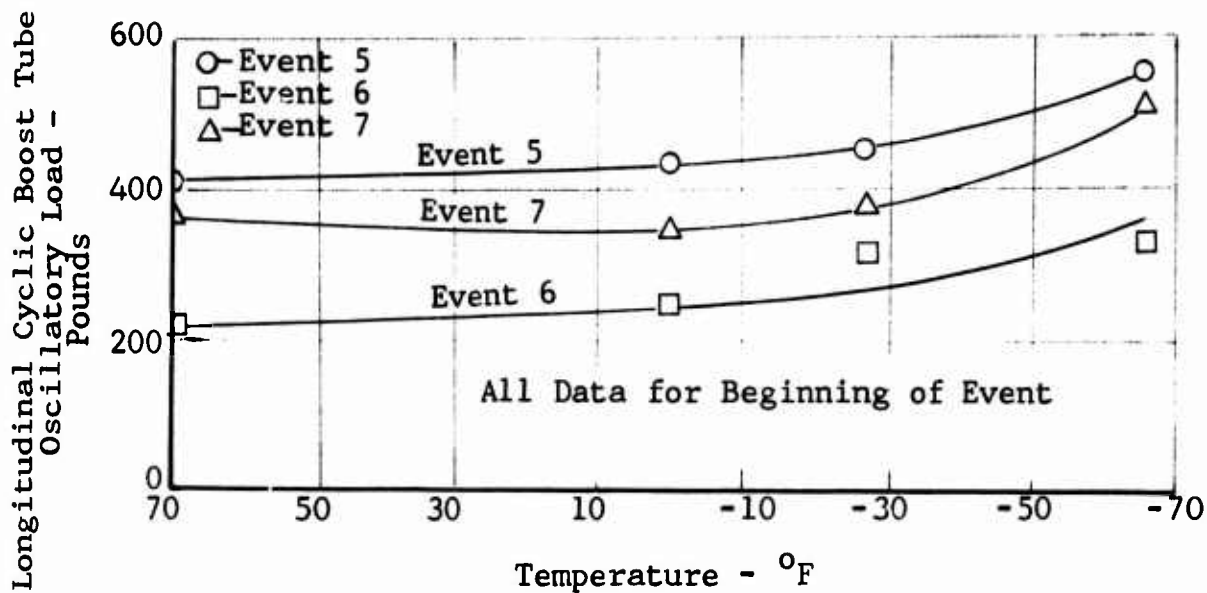
Figure 16. Longitudinal Cyclic Boost Tube Oscillatory Load Versus Temperature.

Figures 16 and 17 illustrate the behavior of longitudinal and lateral cyclic boost tube load with decreasing temperature. Both plots convey essentially the same information. The rise in oscillatory load with temperature decrease is moderate, and the maximum load is well below the endurance limit of 1260 pounds.

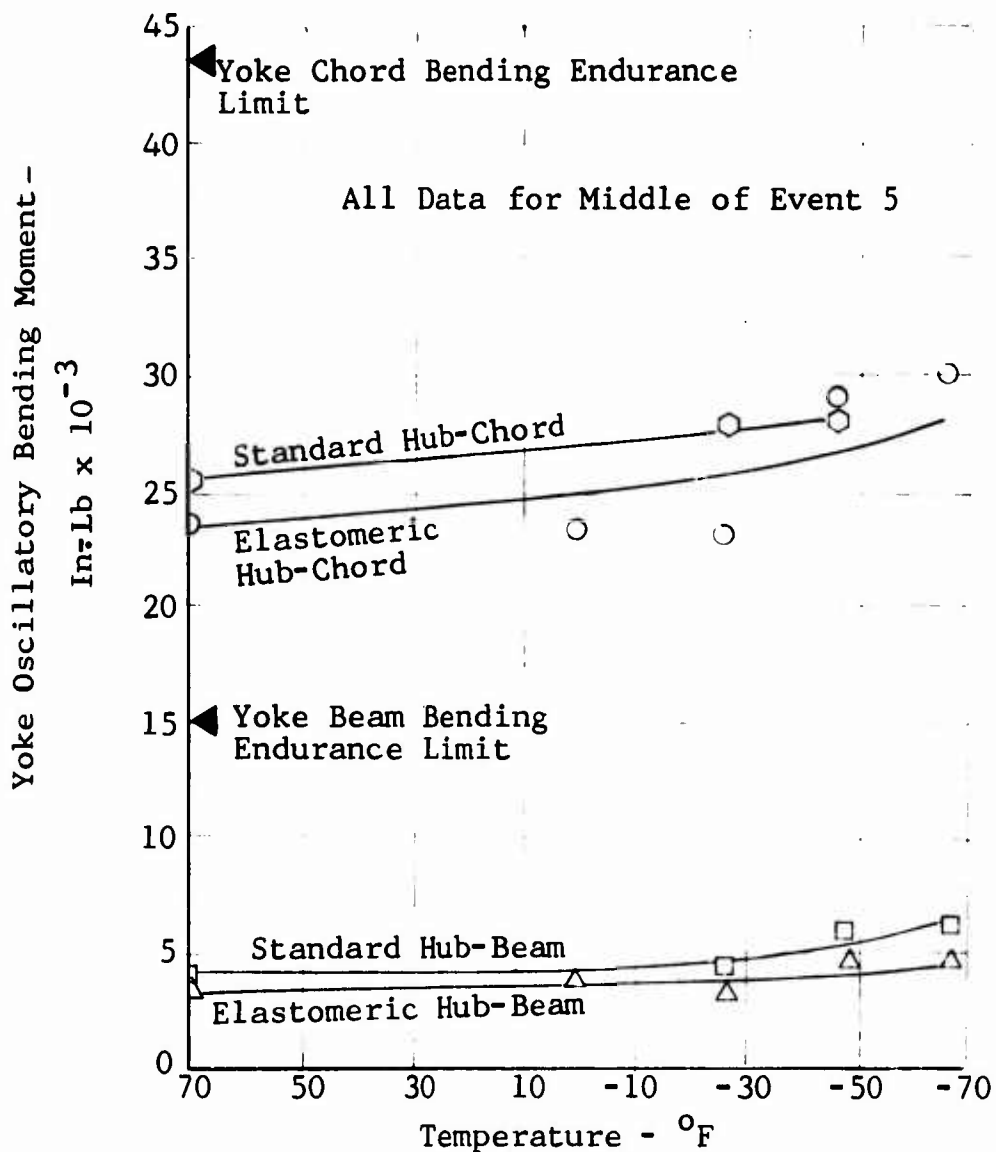
Figure 18. Main Rotor Yoke Bending Versus Temperature.

Figure 18 depicts the behavior of main rotor yoke chord and beam bending with temperature variation for both the standard and elastomeric rotors. The purpose of the plot is to show that rotor loads are not substantially different for the two hubs, and that loads are well below the endurance limits.

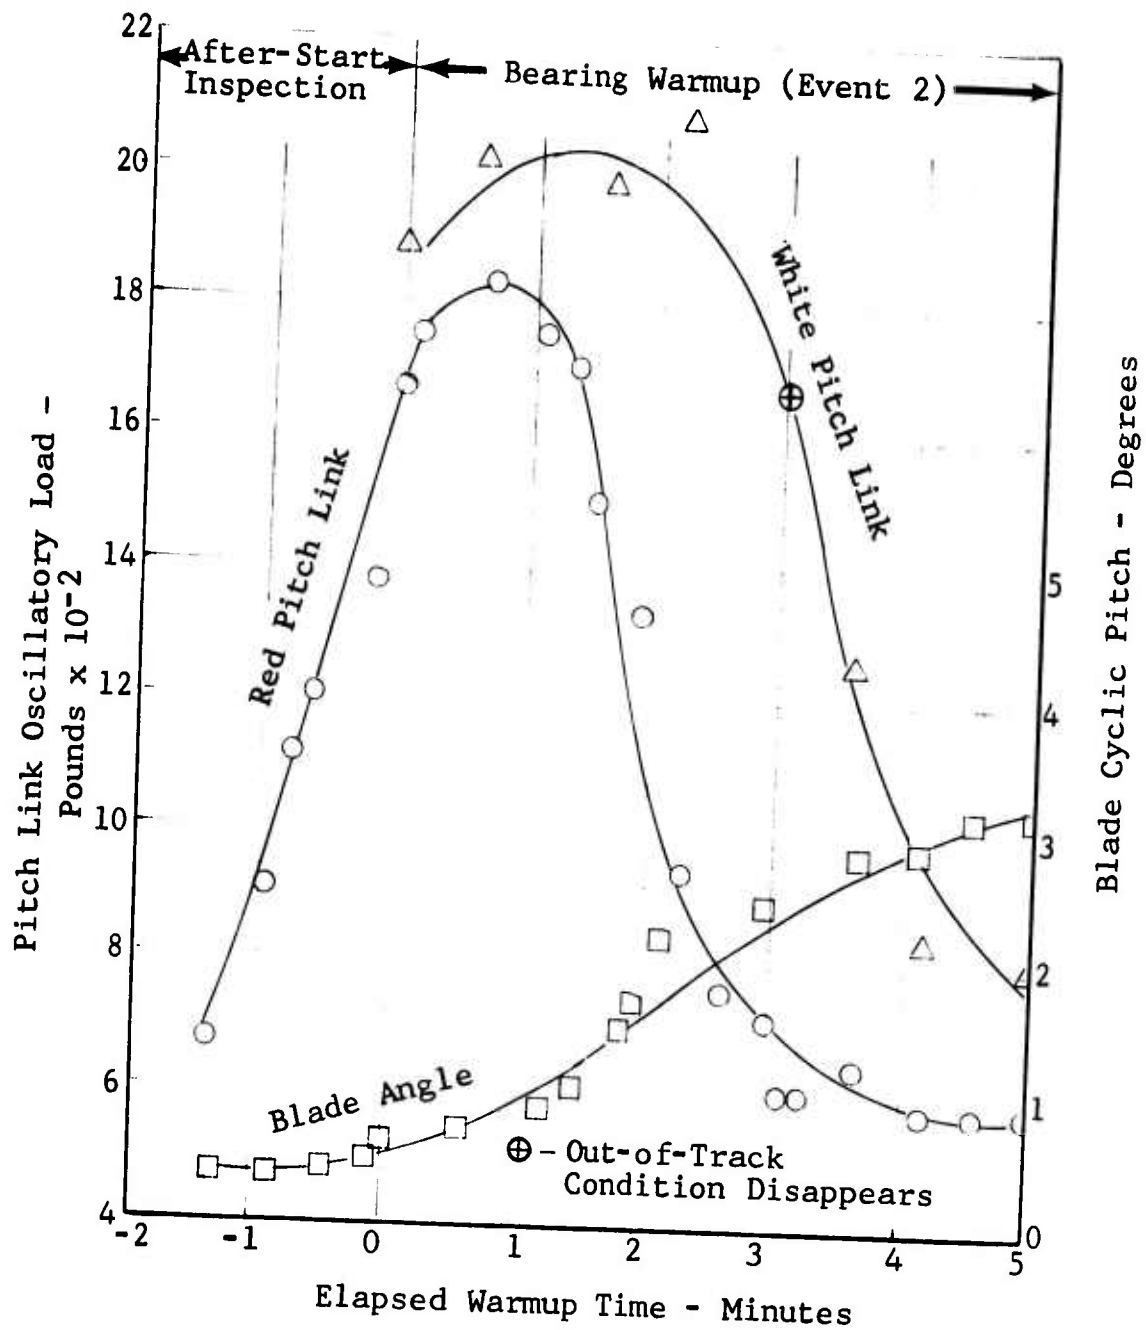
Figure 19. Rotor Behavior During Warmup at -65°F (GR 56).

The large magnitudes of oscillatory pitch link load, and the large disparity between the red and white pitch link oscillatory loads, are evident. In the worst case, the white pitch link oscillatory load is over twice that of the red pitch link.

The initial cyclic inputs (prior to time zero) produced large oscillatory loads in the pitch links. Since the difference in oscillatory loads was caused by differential bearing spring rates, the difference in loading would have increased had control inputs been larger.

These figures illustrate the bearing warmup characteristics found in all three tests at -65°F (GR 55, 56, and 57) in which the elastomeric pitch-change bearings were not heated prior to engine start. Initially, the bearings are extremely stiff, and even a small cyclic control input produces large oscillatory control loads. Since the red and white sides of the hub existed in different temperature environments prior to engine start, bearing warmup was begun with different torsional spring rates for the red and white bearings. Thus, different oscillatory loads are found in the red and white pitch links. Although only a small cyclic pitch angle of about 0.3 degree was maintained prior to the beginning of the warmup event of GR 56 (during the crew chief's inspection), it is in this period that the maximum effective spring rates are found (about 3600 pounds per degree for the red grip). Spring rates for the white grip were larger, since those bearings were colder, but since white blade pitch angle was not recorded, a corresponding value is not available.

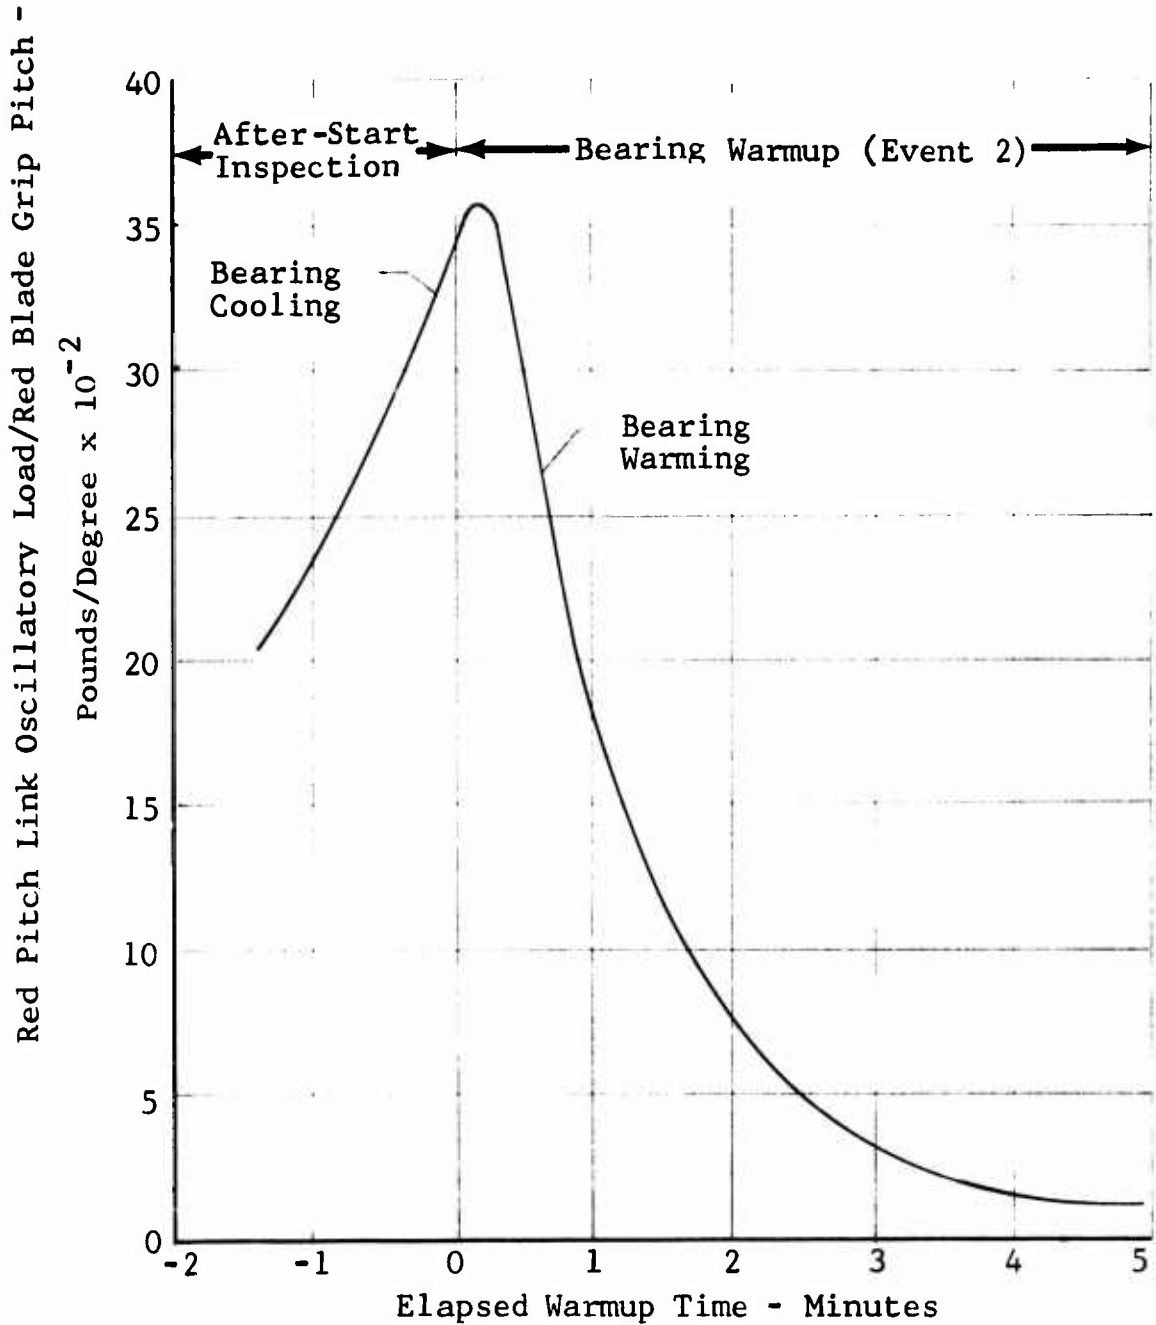
Figure 20. Pitch Change Bearing Effective Spring Rate During Bearing Warmup at -65°F (GR 56).

Figure 20 is a plot of red pitch link load/red blade grip angle versus time for the warmup period of GR 56. This is a cross plot of data contained in Figure 19. This is not strictly a plot of bearing spring rates, since the spring rate of the control system is also involved in the "effective" spring rate.

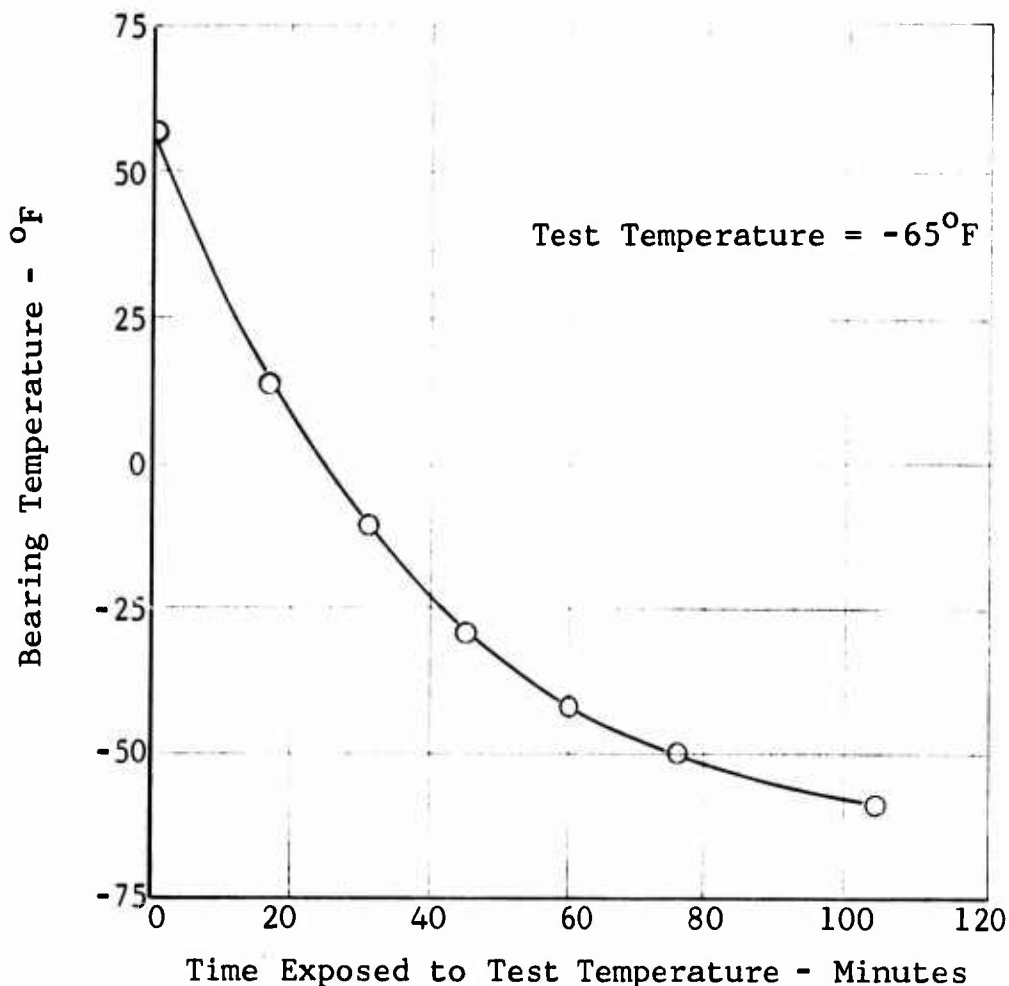
Figure 21. Pitch Change Bearing Temperature Behavior When Exposed to Temperature Differential.

Figure 21 illustrates another interesting fact: the bearing elastomer changes temperature rapidly when subjected to large differential temperatures. These data were obtained from a thermocouple inside an elastomeric bearing placed atop the hub during the "soak" period of GR 59. The bearing was brought from a warm room and placed directly in a -65°F environment. The average coefficient of temperature change of the bearing is about $.02^{\circ}\text{F}/\text{minute}/^{\circ}\text{F}$ temperature differential.

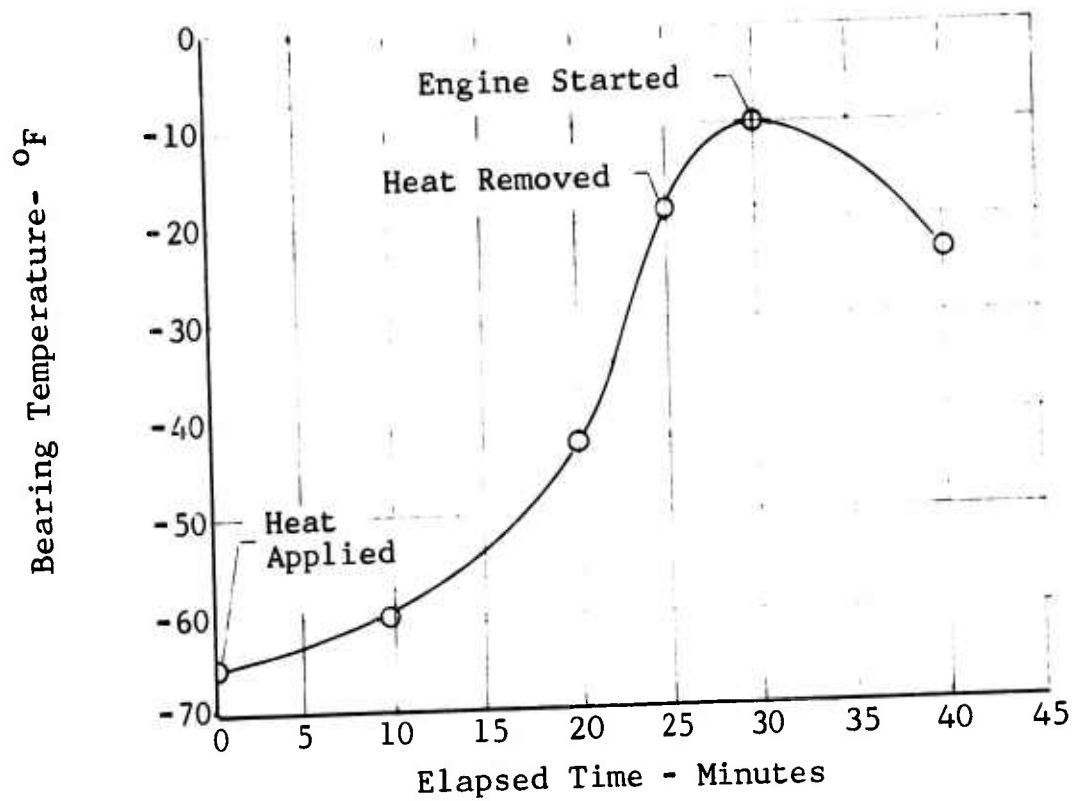
Figure 22. Bearing Warming Characteristics During Preflight at -65°F.

A plot of elastomeric bearing temperature change during preheat of the transmission input shaft coupling seals before GR 59 (using the canopy cover) showed a rise in bearing temperature (interior elastomer) of 45°F in about 25 minutes. The elastomer temperature continued to rise for about 5 minutes after the heating was terminated, then showed a sharp decrease when the engine start was begun. A time history by these actions during GR 59 is shown in Figure 22.

It appears that the bearing elastomer changes temperature more rapidly than had been thought, thereby allowing a rapid warming of the bearings by using a simple "tent" to conduct heat from the transmission area to the hub during preflight heating of the transmission input shaft coupling seals.
